**Garland Independent School District
(Garland ISD)**

REQUEST FOR PROPOSAL (RFP)

FOR: Bleacher Replace and Repair

NOTE: RFP #471-16

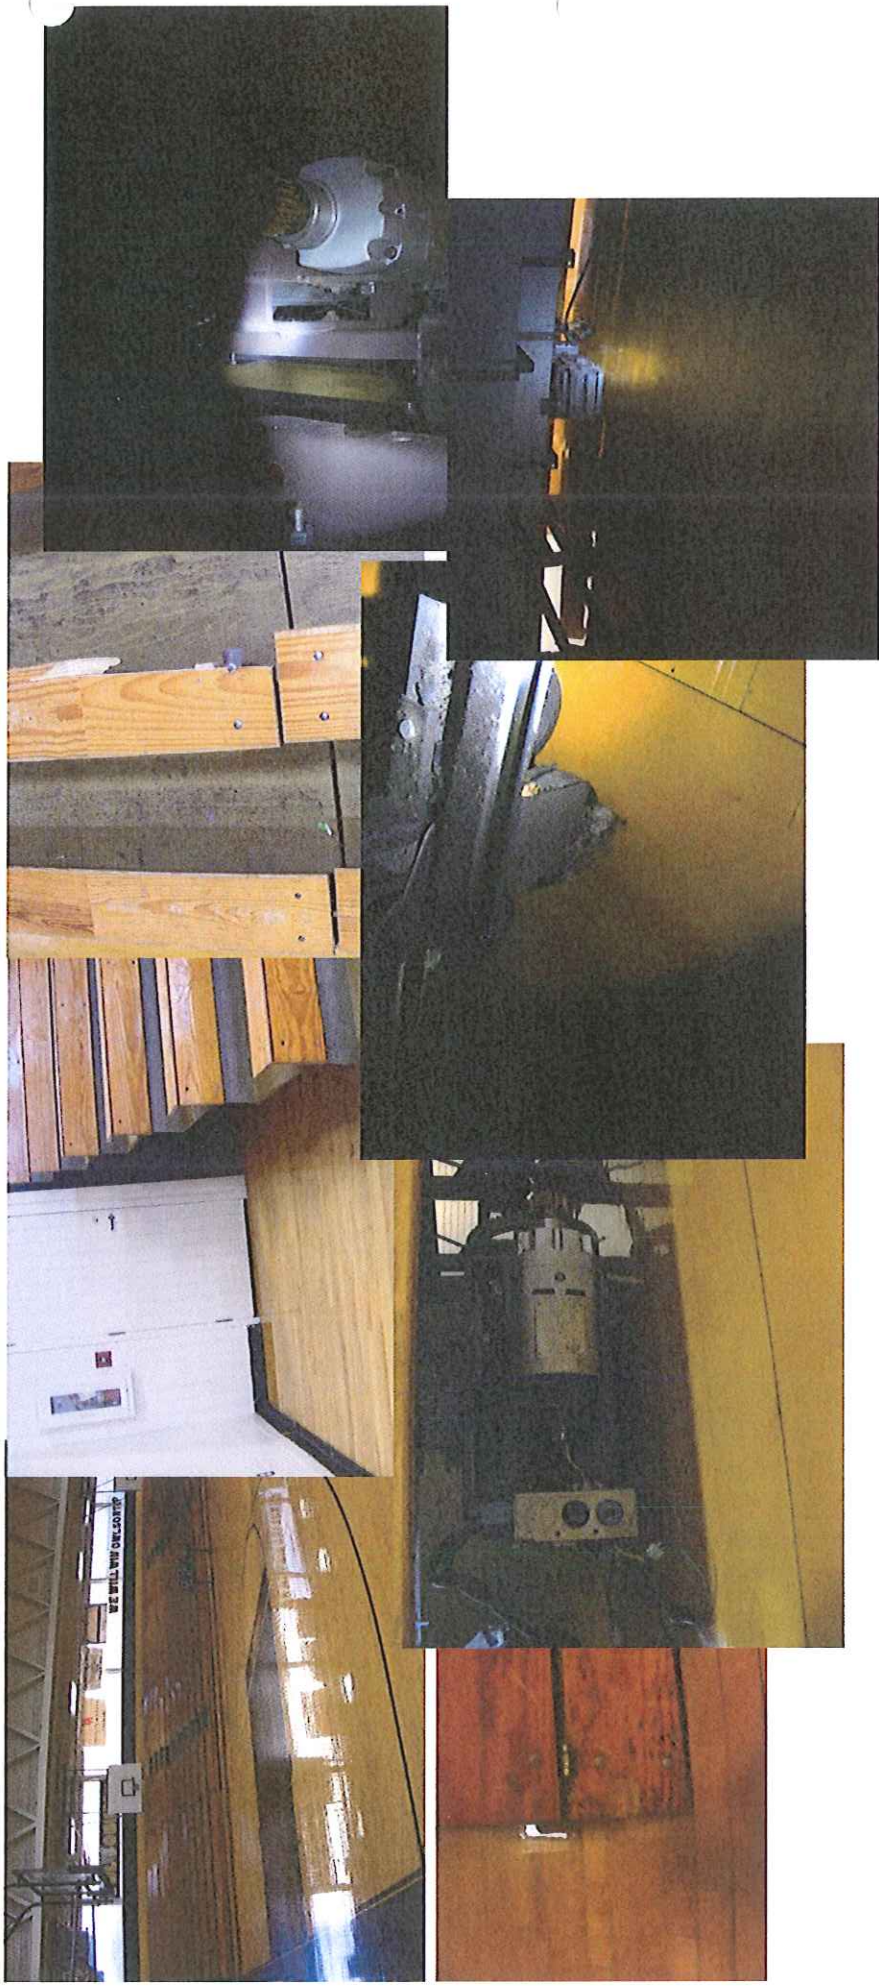
Garland ISD Bleacher Assessment 1

The aisles and rows of this bleacher system are clear of obvious debris and trash and seem to be kept clean on the tops of the seats and floor boards. There are several areas of concern with this bleacher system including broken seat boards, broken riser boards, several sharp or splintery edges from the wooden seats or metal frame, and missing hardware and seat braces. There are approximately six broken seat boards that pose a walking and splinter hazard. The seats are very uneven and most of them are loose due to missing hardware or wear and tear. There are approximately five broken riser boards that are dragging the floor causing damage. Most of the wood on this system is worn and splintery. The front hinges are bent or loose and not working correctly. This system also does not have a handrail for the aisles or a guardrail for the open sides. This is a definite safety hazard for students, employees and spectators.

The understructure of this bleacher system was found in a dirty state. The tracks, track wheels and other moving parts were found to have a buildup of gum, dirt and other debris. This will place the moving parts in a bind and aide in the system not working properly or in the parts failing all together. This system was found to be secured to the floor and or wall properly. The motors were found without safety covers and some of the wires were hanging loose and need to be attached in a safe manner. The drive wheels were found to have very worn tread and will need to be replaced soon. The track wheels were found in bad condition. These wheels are very old and several are cracked. Most all the track wheels had trash stuck to them. All of the brakes, stops and locks have been worked on before and are failing again. The system does not seem to be locking in a stable position when telescoped in the outward position. This system has missing hardware and braces that could cause the system to fail structurally. The entire system has already been "Jack and Welded" and in my opinion is at the end of its life. The floor under the bleacher system seems to be visibly level and not causing any harm to existing or future bleachers. The understructure and movement system of this bleacher system is in overall bad condition.

This bleacher system does not telescope without the help of manual labor. Overall the bleacher system is in bad condition and is not in good working order or safe for students, staff or spectators. The power system and structural systems are failing causing the bleacher system not to work properly. Garland ISD has decided to remove the bleacher system at Garland High School in the competition gym and replace it with new bleachers.

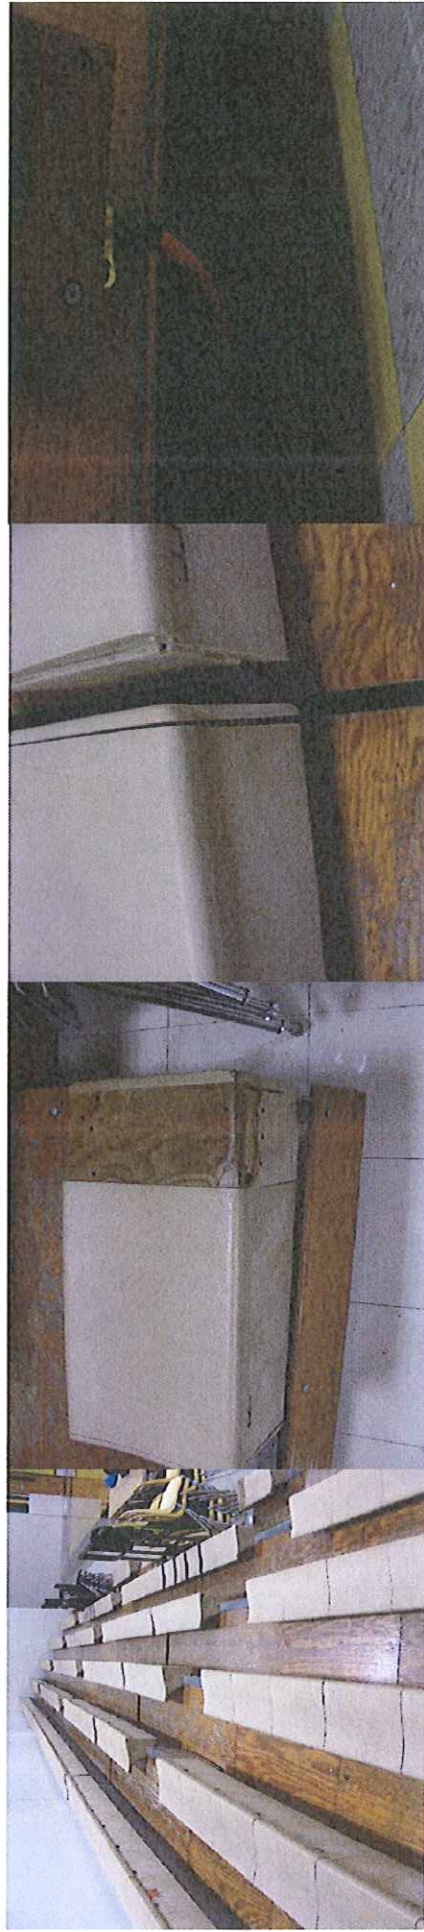
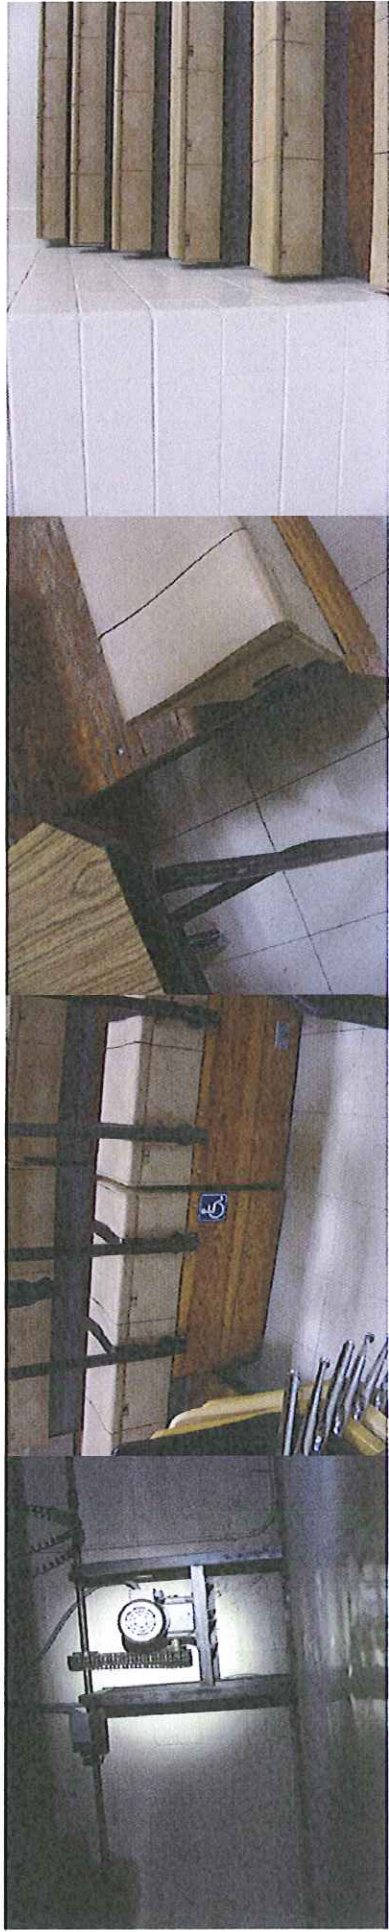
Garland ISD Bleacher Assessment 2

The aisles and rows of this bleacher system are clear of obvious debris and trash and seem to be kept clean on the tops of the seats and floor boards. There are several areas of concern with this bleacher system including; broken seat modules, sharp areas from the broken seats either plastic or metal frame, loose deck planks, and missing hardware. There are approximately three broken seats that pose a walking and or hazard to the user. There are approximately two loose deck planks that could be hazardous to walk on. The front hinges are bent or loose and not working correctly. These are what unlock the braking system to help it to telescope correctly. This system does not have a handrail for the aisles and does not need a guardrail for the open sides because there are walls at both ends. Overall the top of this system is in fair condition but is older. It does telescope in a working condition but could be better with a little work.

The understructure of this bleacher system was found in a dirty state. The tracks, track wheels and other moving parts were found to have a buildup of gum, dirt and other debris. This will place the moving parts in a bind and aide in the system not working properly or in the parts failing all together. This system was found to be secured to the floor and or wall properly. The track wheels were found in good condition. Most all the track wheels had debris stuck to them and would work better if cleaned. All of the brakes and stops seem to be working properly. The row locking system does not seem to be locking in a stable position when telescoped in the outward position. This could allow for the system to move backward when stepping up on the bleachers. This system has no visible broken welds that could cause a structural fail. The floor under the bleacher system seems to be visibly level and not causing any harm to existing or future bleachers. This bleacher system seems to retract and extend in a correct manner. It could work better if it was cleaned, degreased and lubricated again.

This bleacher system telescopes in a manner consistent with its age. Overall the bleacher system is in fair condition but needs immediate attention in order to be safe for students and spectators. Garland ISD has decided to replace the bleacher system in the DEBS Girls Gym.

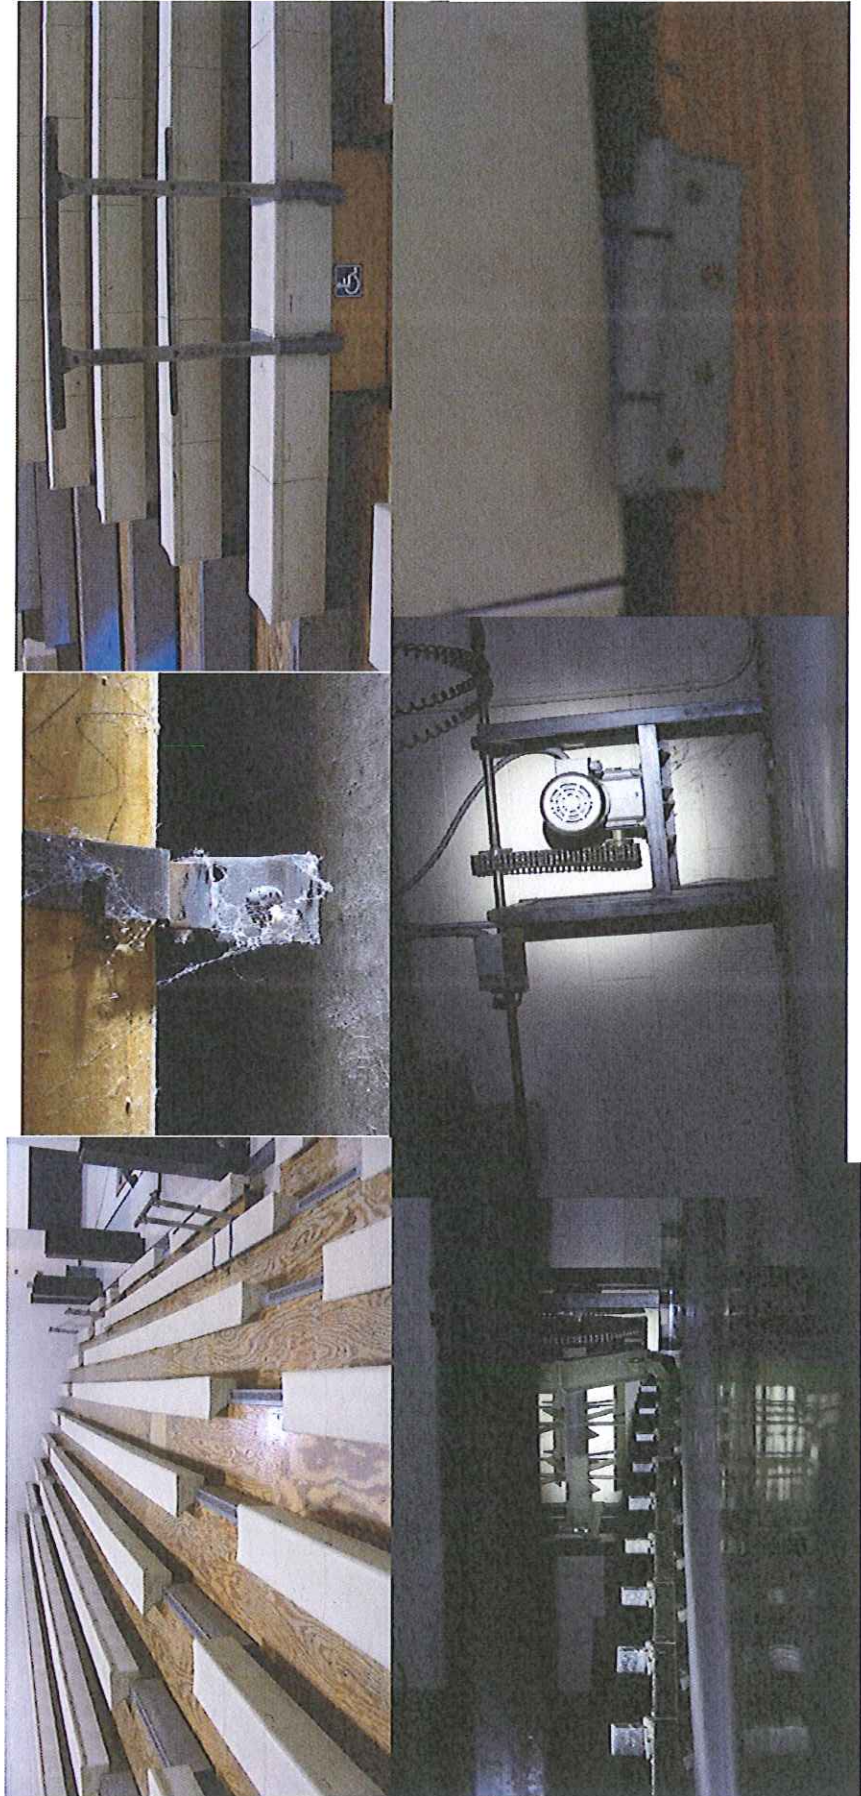
Garland ISD Bleacher Assessment 3

The aisles and rows of this bleacher system are clear of obvious debris and trash and seem to be kept clean on the tops of the seats and floor boards. The aisles and steps seem to be in safe working condition. There are a few areas of concern with this bleacher system including broken riser boards, several sharp edges from the metal frame, and missing hardware. There are approximately three broken riser boards that pose a hazard. Those three broken riser boards are dragging the floor causing damage and posing a tripping hazard and a danger for someone getting cut. The front hinges on those riser boards are bent or loose and not working correctly. This needs to be addressed soon. This system does have a handrail for the aisles and is set at thirty inches. Overall the tops of the bleachers is in good condition but riser boards and hinges on the bottom row could pose a danger for students, staff and spectators.

The understructure of this bleacher system was found in a clean state. The tracks, track wheels and other moving parts were found to have limited or no gum, dirt and other debris. This system is hard to access underneath and needs to be lubricated more often. This system was found to be secured to the floor and or wall properly. All of the wiring is secured properly and out of the way of moving parts. The motors were found in a safe working manner. The drive wheels were found to be in good condition. The track wheels were found in good condition. All of the brakes, stops and locks have been found in good and safe working condition. All the row interlocks seem to be working properly. The front hinges are broken and need replacing. This bleacher system extends and retracts consistent to the age of the bleacher system. The floor under the bleacher system seems to be visibly level and not causing any harm to existing or future bleachers.

This bleacher system seems to telescope properly with the motorized system. Overall the bleacher system is in good condition. The power system and structural systems seem to work properly. Garland ISD has decided to keep the bleacher system at Bussey Middle School in the boys and girls competition gym and make necessary repairs.

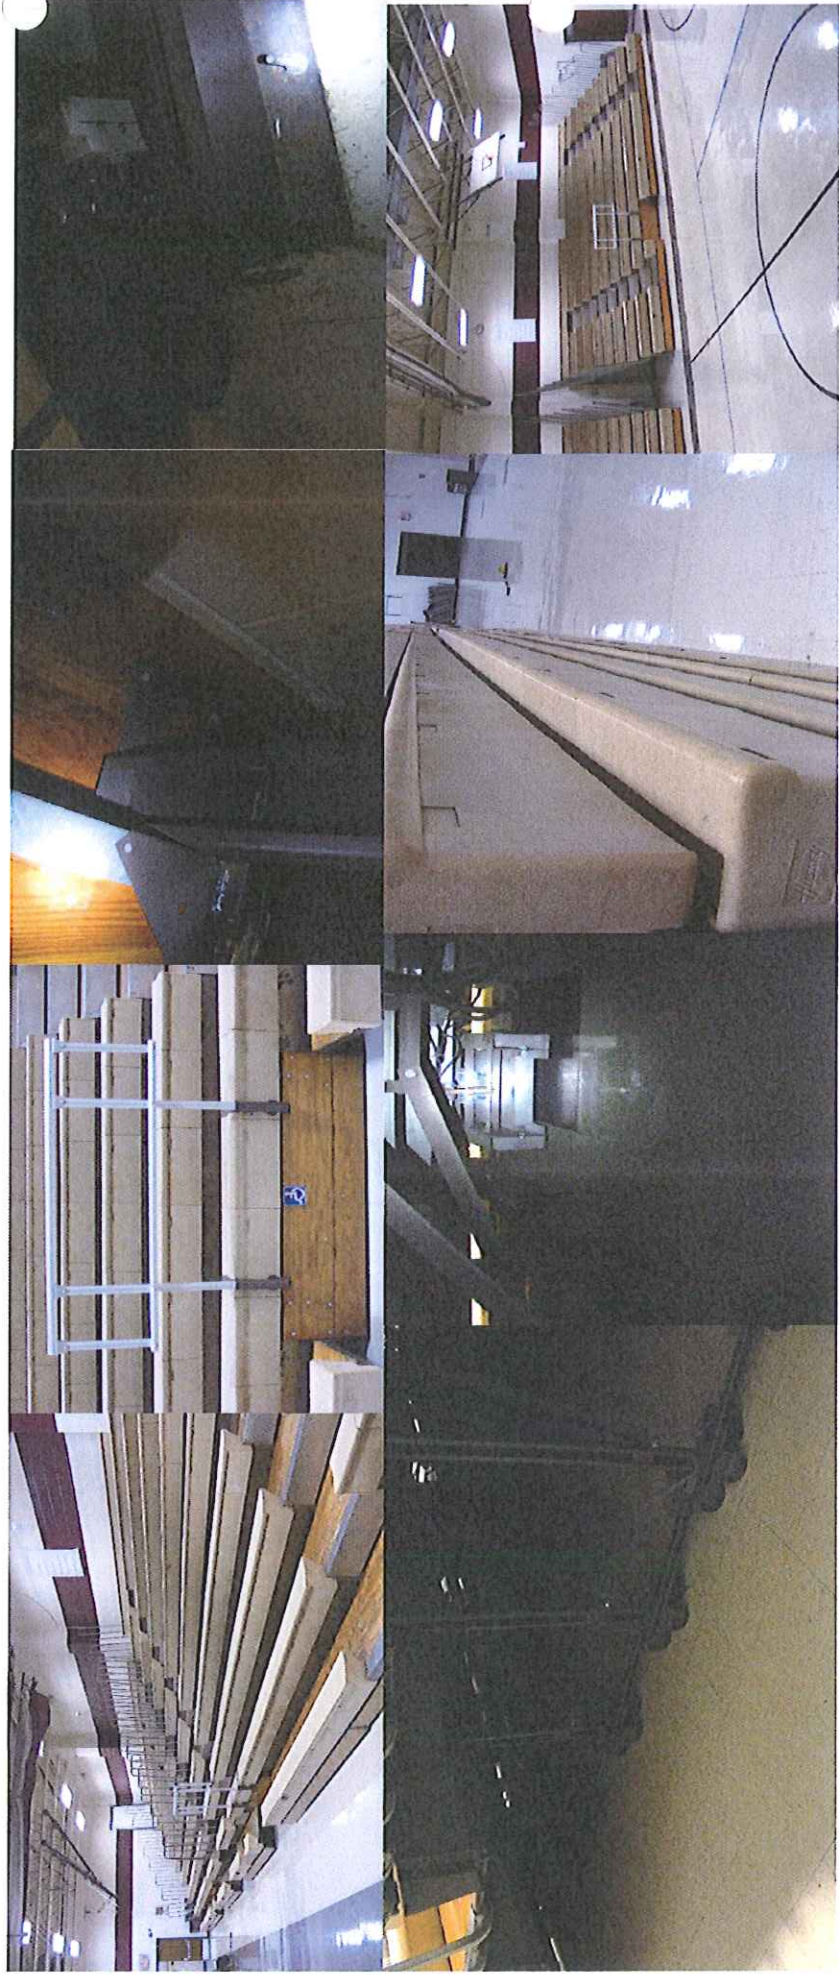
Garland ISD Bleacher Assessment 4

The aisles and rows of this bleacher system are clear of obvious debris and trash and seem to be kept clean on the tops of the seats and floor boards. The aisles and steps seem to be in safe working condition. There are several areas of concern with this bleacher system including broken seat modules, broken riser boards, several sharp edges from the broken seat or metal frame, and missing hardware and end covers. There are approximately one broken seat module that pose a hazard because of its shape edges. There are approximately one broken riser board that has some hardware missing from it as well. There is one handicapped guardrail missing from the system. This system does not have a handrail for the aisles. This system does have a guardrail for the open side set at four feet. The top area of these two banks are in overall good condition.

The understructure of this bleacher system was found in a relatively clean state. The tracks, track wheels and other moving parts were found NOT to have a buildup of gum, dirt and other debris. This system was found to be cleaned and lubricated in a proper manner. This system was found to be secured to the floor and or wall properly. The motors and electrical cords were all properly secured and were attached in a safe manner. The drive wheels were found to be in very good condition. The track wheels were also found in good condition. All of the brakes, stops and locks were in good working condition. The entire system has already been "Jack and Welded" and in my opinion, seems to still be working great. There are no visible broken welds, missing hardware or bracing. There is one catch in the middle track on the first bank causing it not to retract all the way. This does not seem to be causing any harm or structural disadvantages. The floor under the bleacher system seems to be visibly level and not causing any harm to existing or future bleachers.

This bleacher system seems to be in great working order. Overall the bleacher system is in good shape and should be safe for students, staff and spectators. Garland ISD has decided to keep the bleacher system at Sellers Middle School in the competition gym and perform necessary repairs.

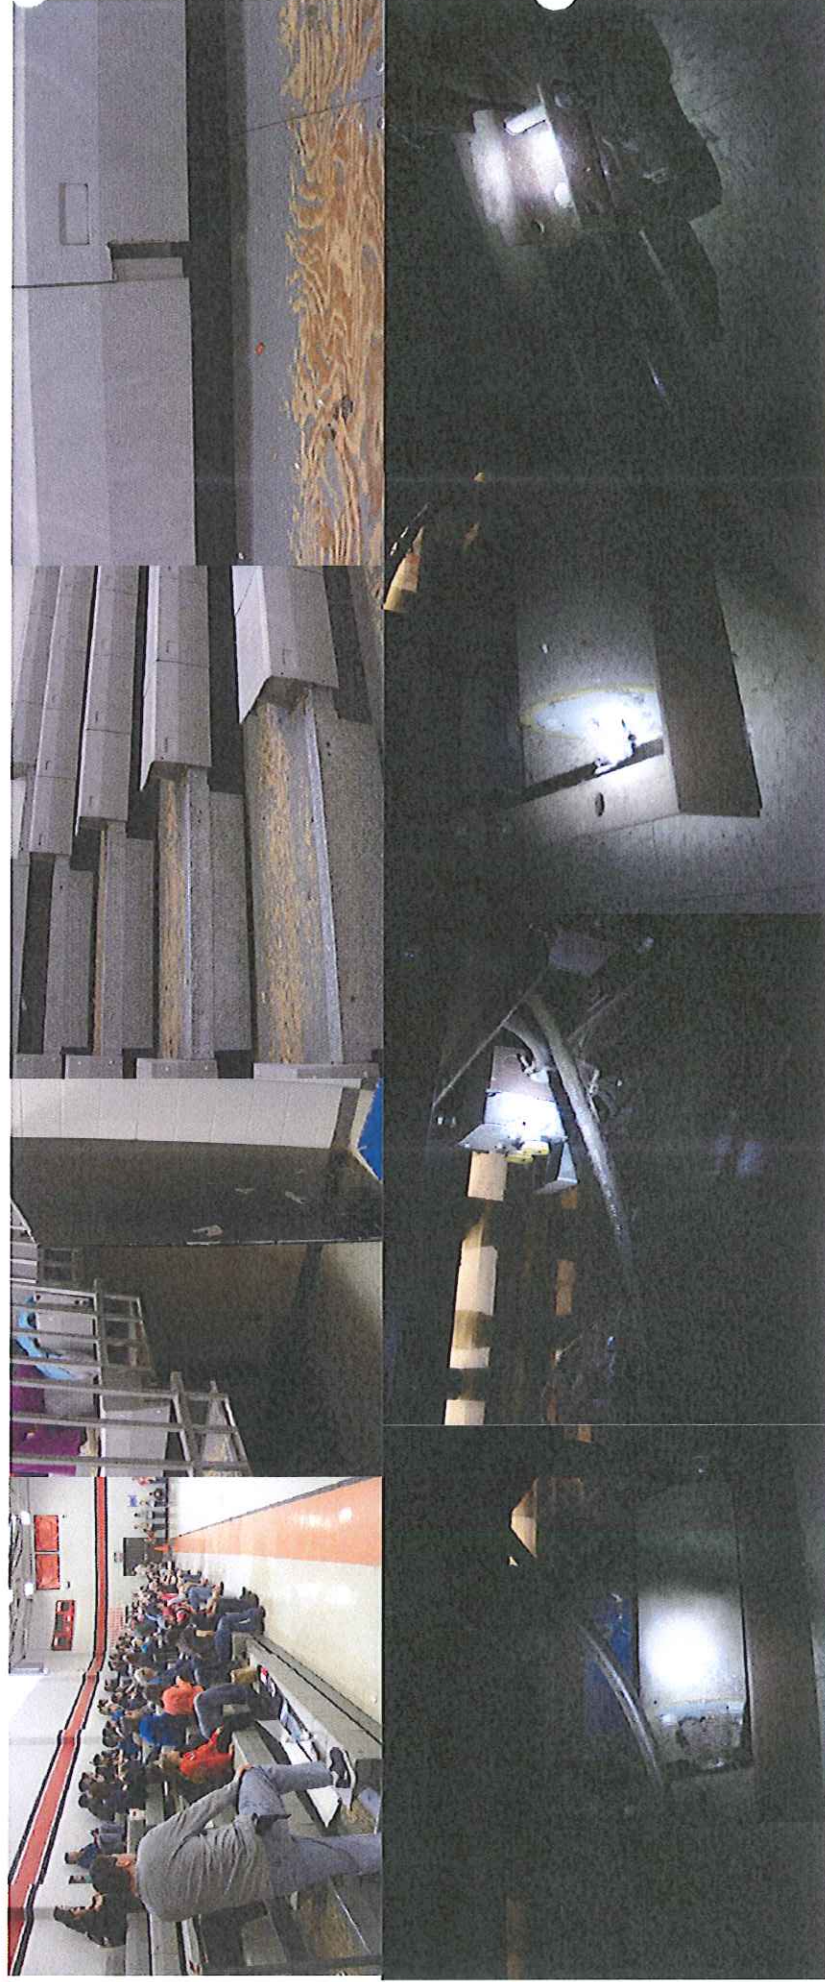
Garland ISD Bleacher Assessment 5

The aisles and rows of this bleacher system are clear of obvious debris and trash and seem to be kept clean on the tops of the seats and floor boards. The aisles and steps seem to be in safe working condition. There are several areas of concern with this bleacher system including: broken seat modules, sharp areas from the broken end caps and seat modules and missing hand rails. There are approximately fifteen broken or missing end caps. The front hinges are bent or loose and not working correctly. These are what unlock the braking system to help it to telescope correctly. This system does not have a handrail for the aisles but does have a guardrail for each end on the open sides. Overall the top of this system is in good condition. They have been painted grey and it looks are good. It does telescope in a working condition but could be better with a little work.

The understructure of this bleacher system was found in a dirty state. The tracks, track wheels, drive wheels and other moving parts were found to have a buildup of gum, dirt and other debris. This will place the moving parts in a bind and aide in the system in not working properly or in the parts failing all together. This system was found to be secured to the floor and or wall properly. One of the electrical cords needs to be fastened to the system properly as not to get damaged in the telescoping process. The drive wheels are beginning to wear because of all the debris coming in contact with the wheels but still contain enough tread to work properly. The track wheels were found in a dirty condition. Most all the track wheels had debris stuck to them and would work better if cleaned. All of the stops seem to be working in a proper manner. The row locks need to be removed, repaired and then placed back on the system. This could allow for the system to move backward when stepping up on the bleachers or not lock into the proper position. This broken brake will also cause damage to the floor if moved before it is repaired. This system has no visible broken welds that could cause a structural failure. This bleacher system has been "jack and Welded" but the metal frame seems to be in good condition. The floor under the bleacher system seems to be visibly level and not causing any harm to existing or future bleachers. This bleacher system could work better if it was cleaned, degreased, lubricated again and the brake was repaired.
